Engine analysis

Uses of IR thermography

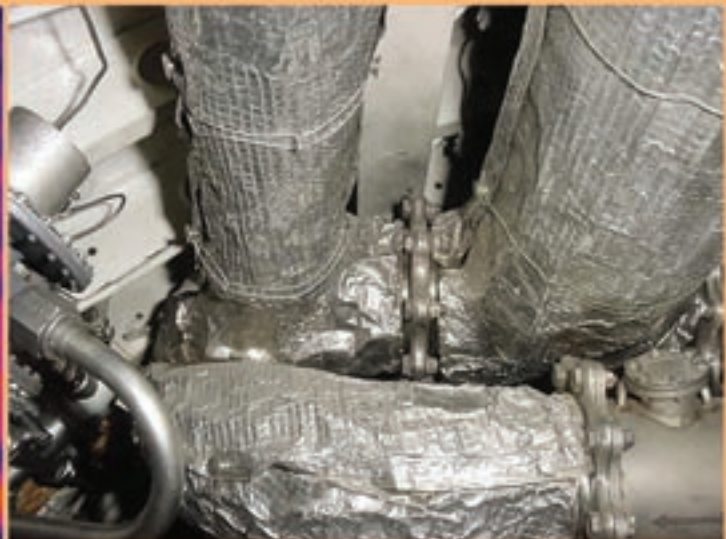
S-3B crossover valve used in the test.

Heat is a good indicator of a defective, or soon-to-be-defective, hydraulic valve. The force of fluid moving through a leak or restriction will produce heat; however, not every leaking hydraulic valve will produce heat. The proximity of the valve, to other
